**Flood Control Project Maintenance
Levee Inspections**
LMA District Cover Sheet
Spring 2014 Levee Inspection Results

Reclamation District No. 0524 Middle Roberts Island

Spring 2014 Levee Inspection Results

| Waterway | | | Bank | Unit Miles |
|--|---|---|---|---|
| Unit No. 01 San Joaquin River | | | Left | 6.26 |

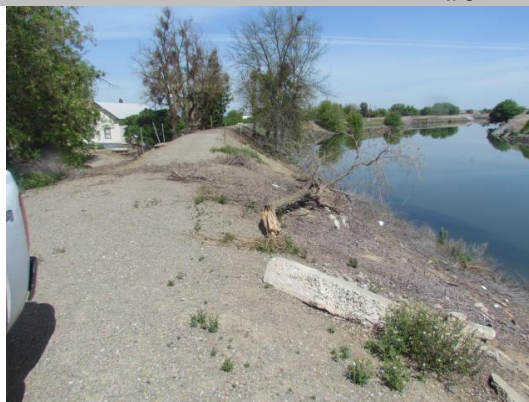
Photo 1 of 1 : richard_s_20140411_526.jpg

| Inspector Comments: Tree limb on waterward shoulder. | | | | | |

Looking northeast at tree limb on waterward slope.

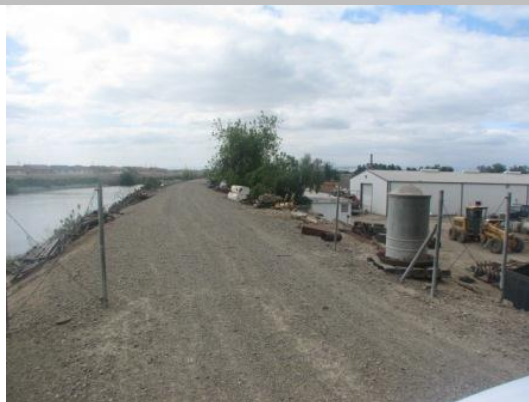
Photo 1 of 2 : richard_s_20140320_171.jpg

Looking upstream at equipment on landside shoulder

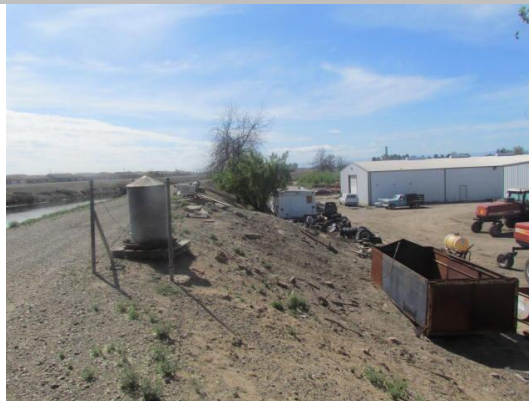
Photo 2 of 2 : richard_s_20140320_172.jpg

Looking south at northend of equipment stored at landward slope and toe.

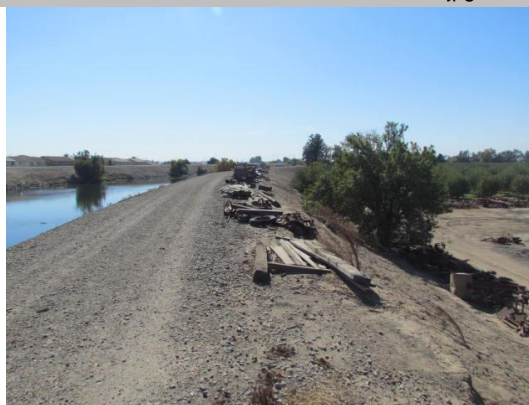
Photo 1 of 3 : richard_s_20140320_192.jpg

| Inspector Comments: Landowner is storing equipment on landward shoulder and landward toe. | | | | | |

Looking south at farm equipment stored on landward shoulder and toe.

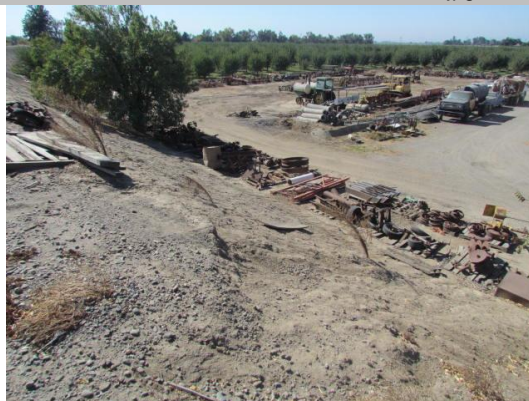
Photo 2 of 3 : richard_s_20140320_193.jpg

Looking west at farm equipment stored at landward toe.

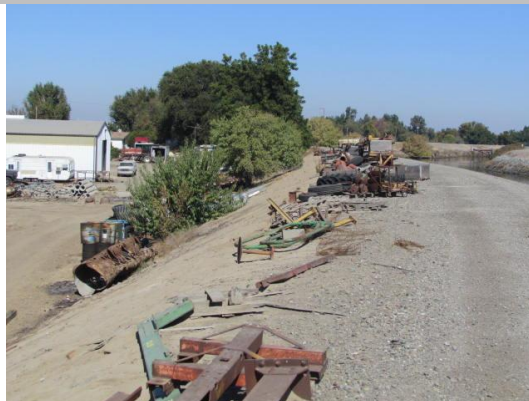
Photo 3 of 3 : richard_s_20140320_194.jpg

Looking north at farm equipment stored on landward shoulder.

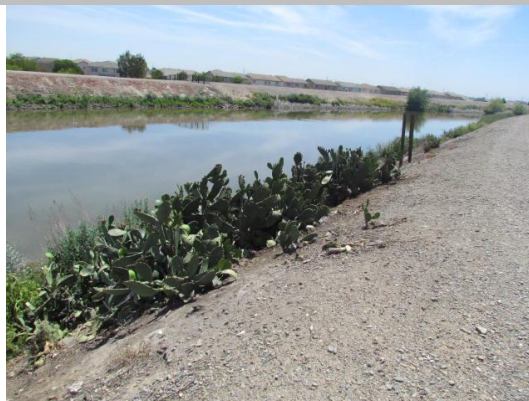
Photo 1 of 1 : richard_s_20140320_191.jpg

Looking southeast at cactus on waterside slope.

| Inspector Comments: Remove cactus | | | | | |

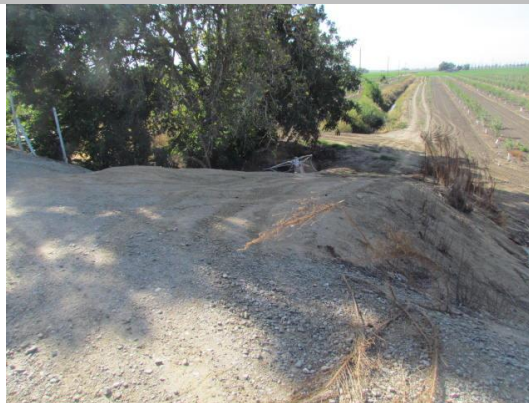
Photo 1 of 1 : richard_s_20140320_196.jpg

| Inspector Comments: Unauthorized ramp. Ramp does not meet Title 23 standard. | | | | | |

Looking west at unauthorized ramp on landside slope.

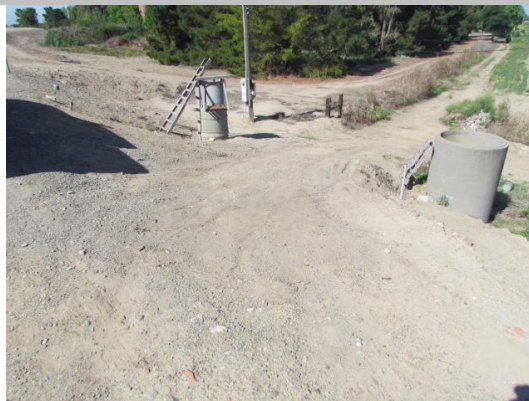
Photo 1 of 1 : richard_s_20140320_206.jpg

| Ramp Inspector Comments: Two unauthorized ramps on landward slope. | | | | | |

Looking southwest at an unauthorized ramp on landside slope.

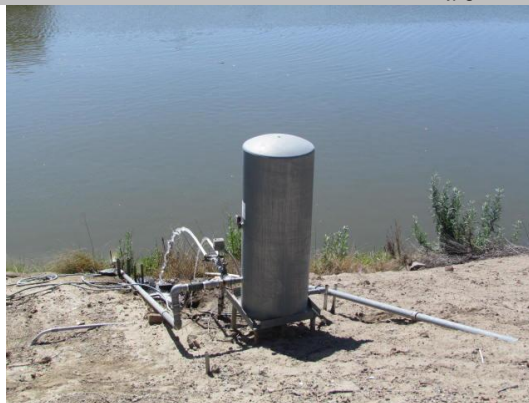
Photo 3 of 4 : richard_s_20140320_204.jpg

| Inspector Comments: Landowner has temporarily repaired pipe with tape. Pipe should be replaced to stop further damage to the levee. | | | | | |

Looking east at irrigation system on waterside slope.

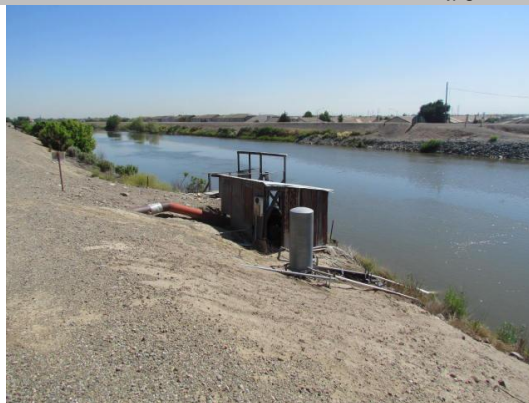
Photo 4 of 4 : richard_s_20140320_205.jpg

Looking northeast at overview of irrigation system on waterside slope.

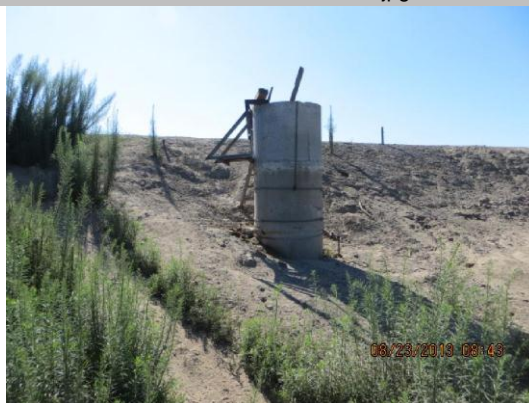
Photo 1 of 1 : UCIP_1664.jpg

Concrete standpipe on LS slope.

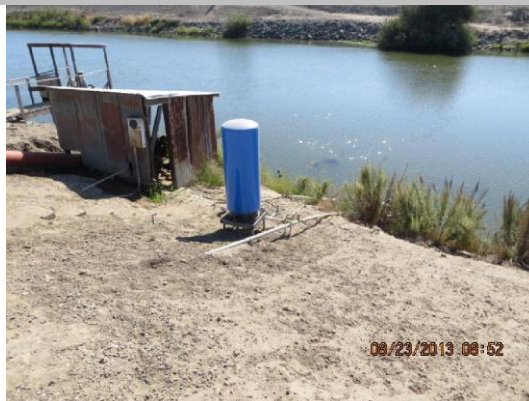
Photo 1 of 1 : UCIP_2813.jpg

Pipe, pump, and tank visible on WS slope.

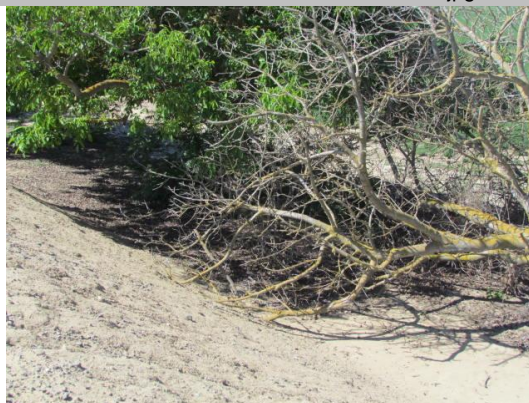
Photo 1 of 1 : richard_s_20140320_207.jpg

| Inspector Comments: Dead tree at landside toe should be removed from levee toe. | | | | | |

Looking west at dead tree at landside toe.

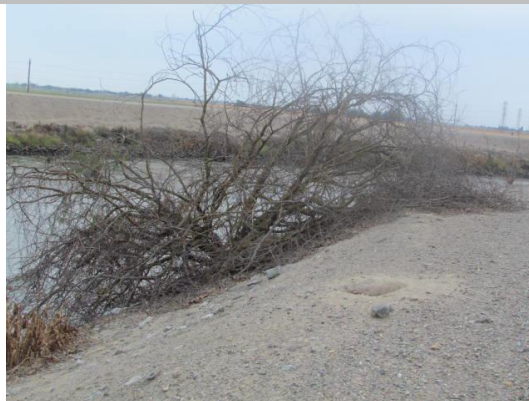
Photo 1 of 1 : richard_s_20140320_197.jpg

Looking southeast at dead tree on waterside slope.

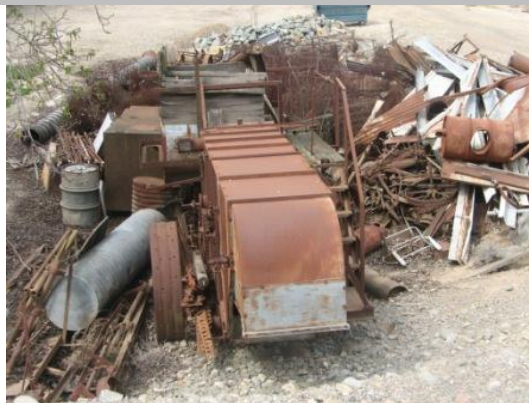
Photo 1 of 1 : richard_s_20140320_174.jpg

Garbage at landward toe next to ramp at LM 4.64

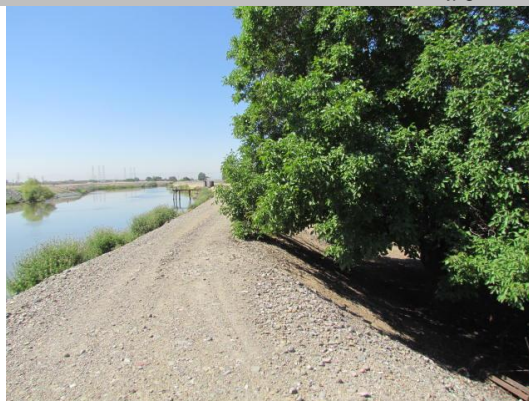
Photo 1 of 1 : richard_s_20140320_173.jpg

Looking south at dense trees on landside slope.

| Trim trees to at least five feet above ground level. | | | | | |

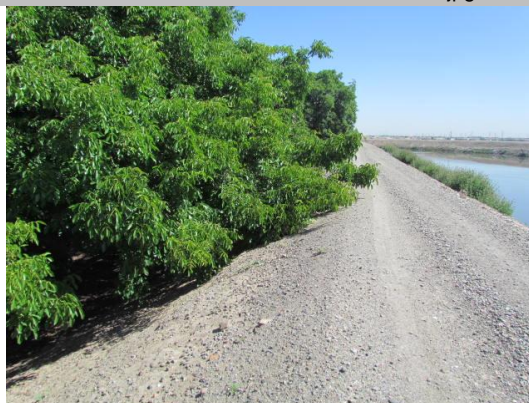
Photo 1 of 1 : richard_s_20140320_208.jpg

Looking north at dense trees on landside slope.

| Trim trees to at least five feet above ground level. | | | | | |

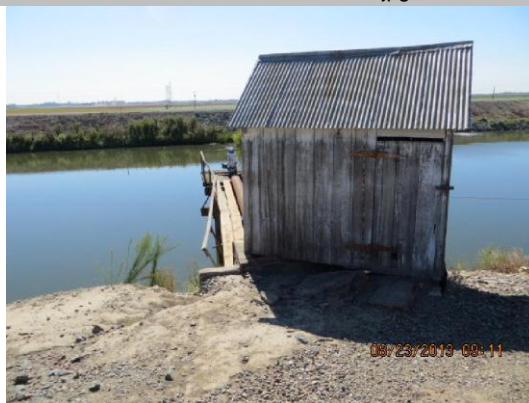
Photo 1 of 1 : UCIP_1672.jpg

| UCIP Comments: Good candidate for video inspection as brick and mortar deteriorating inside tunnel. | | | | | |

Pump on pier and slide gate house on WS shoulder.

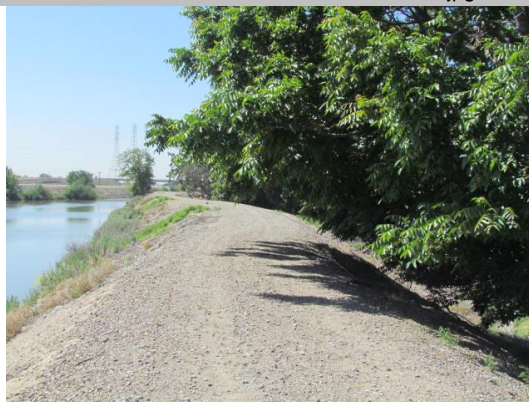
Photo 1 of 1 : richard_s_20140320_175.jpg

Looking south at overhanging trees.

| Trim trees over roadway to at least 12 feet above ground level. | | | | | |

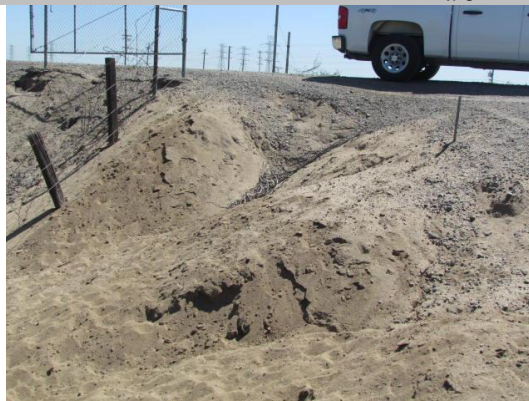
Photo 2 of 3 : richard_s_20140320_211.jpg

| Inspector Comments: Slope damage caused by human activity. | | | | | |

Looking east at slope caving on landside slope.

| Repair slope instability. | | | | | |

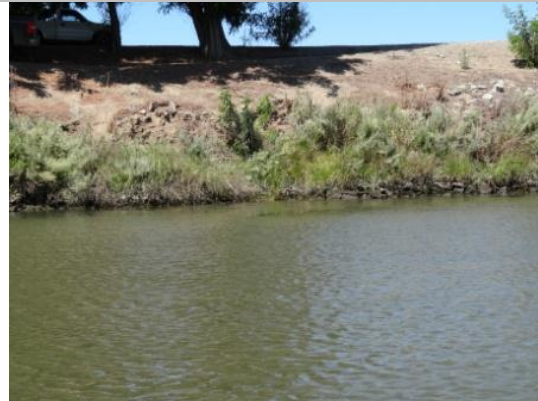
Photo 1 of 1 : richard_s_20140320_236.jpg

| Inspector Comments: 08/13/2013: Larger trees are at the levee shoulder, and an irrigation pump station is next to the erosion site. [2013 Site ID:RD0524U01RM46.06] | | | | | |

Front view of the erosion.

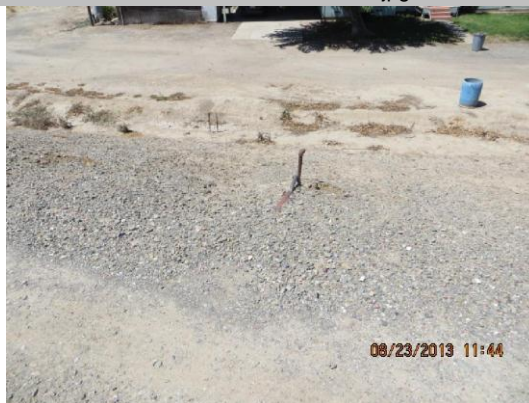
Photo 1 of 1 : UCIP_1683.jpg

Steel conduit and electrical conduit visible on the LS shoulder.

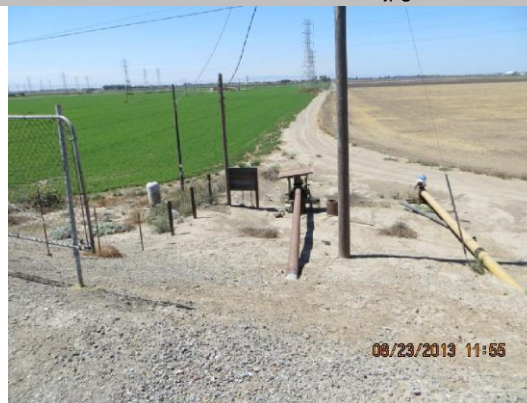
Photo 1 of 1 : UCIP_1685.jpg

UCIP Comments: Apparent leak on WS shoulder at concrete riser.

Pipe, pump, power pole, and meter off LS toe.

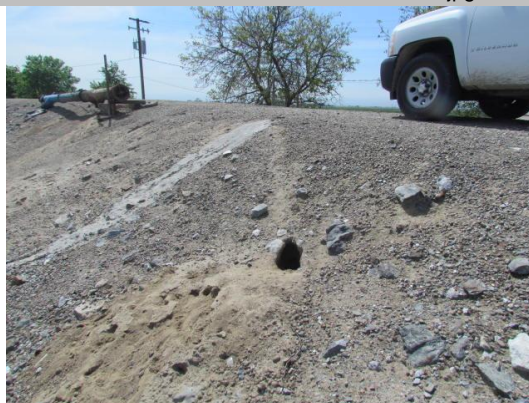
Photo 1 of 1 : richard_s_20140411_527.jpg

| No rodents visible, but rodent burrows visible; need to backfill and compact or grout burrows. Inspector Comments: District has grouted rodent holes, but other rodent holes have appeared. | | | | | |

Looking southwest at typical rodent holes on waterward slope.

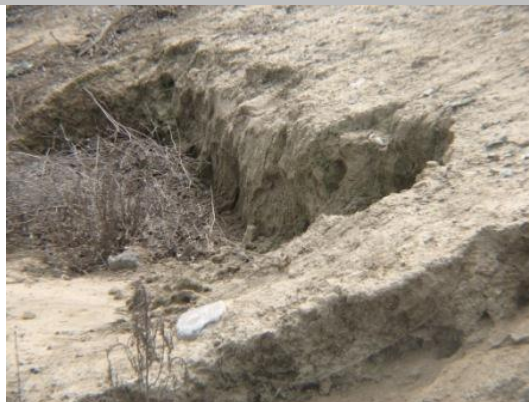
Photo 1 of 2 : richard_s_20140320_176.jpg

Erosion at waterward toe and around irrigation pipe at LM 5.92

| Note and monitor erosion site. | | | | | |

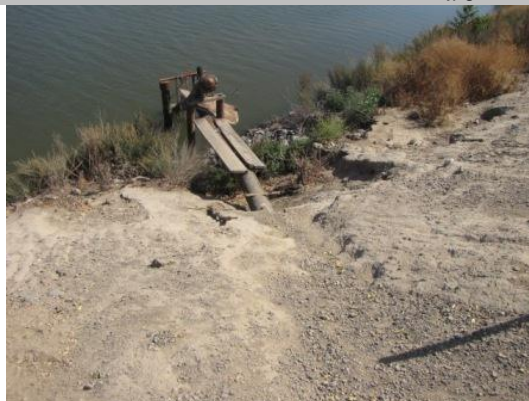
Photo 2 of 2 : richard_s_20140320_177.jpg

Looking southeast at erosion around pipe.

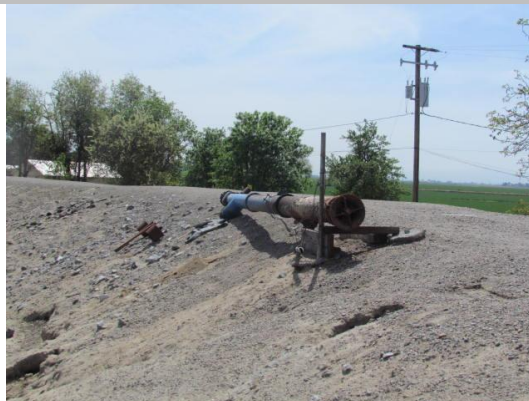
Photo 1 of 1 : richard_s_20140411_528.jpg

Looking southeast at old pump shaft on waterward shoulder.

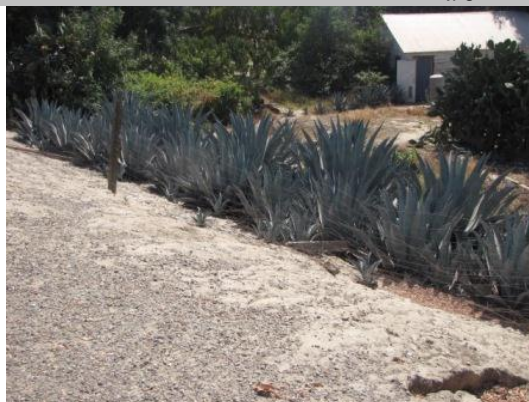
Photo 1 of 1 : richard_s_20140320_184.jpg

| Landscaping Inspector Comments: Cactus | | | | | |

Looking southeast at fence and cactus on landside slope and toe.

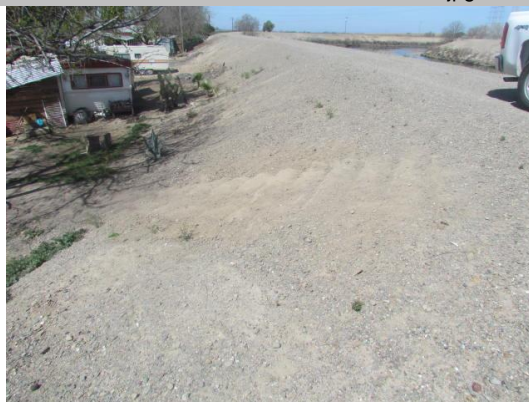
Photo 1 of 1 : richard_s_20140320_251.jpg

| Inspector Comments: Landowner cut steps into landside slope. | | | | | |

Looking north at steps cut into landward slope.

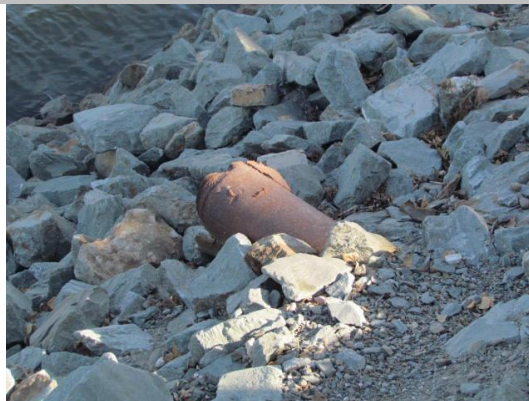
Photo 1 of 1 : richard_s_20140320_245.jpg

| Pipe Inspector Comments: Open abandoned 10" pipe on waterside slope below flood elevation. Pipe should be removed or properly abandoned. | | | | | |

Looking southeast at abandoned pipe on waterside slope.
